## Failure of Life Extended Rotor Discs of Aeroengines

M Sujata, MA Venkataswamy, MA Parameswara, M Suresh Kumar and SK Bhaumik\*  
Failure Analysis Group, Materials Science Division, National Aerospace Laboratories,  
Bangalore 560 017

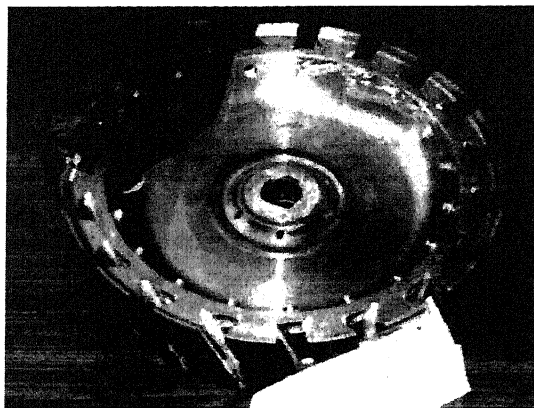
Figure 1 shows the failed compressor rotor disc. The disc had fractured into two pieces; the smaller segment had three dovetail slots, while the larger one had sixteen slots. Fractographic study confirmed that the disc had failed by fatigue (Fig.2). The fatigue crack had initiated at the dovetail fillet region at the trailing edge and propagated at an angle towards the leading edge across the thickness of the disc. No metallurgical abnormalities and/or mechanical damages were observed at the fatigue crack origin. Fluorescent dye penetrant inspection of the fractured pieces revealed three more cracks at the dovetail slot Nos. 5, 8 and 15. These were also fatigue cracks and the crack origin in these cases was identical to that mentioned above.

It may be noted that the disc was in service for 1300 hrs and no cracks were reported to have developed in the disc during this service period. This was confirmed by NDE before life extension. Hence it could be conclusively stated that fatigue crack nucleation and propagation to a critical length had occurred within the 60 hrs of service in the extended life. Also, the possibility of any metallurgical abnormalities in the disc material could be eliminated. It was convincing to arrive at the conclusion that the fatigue crack initiation was stress related. This was further substantiated by the presence of fatigue cracks in a number of dovetail slots at identical locations.

Fig. 1. Fractured compressor rotor disc

Based on the above analysis, it was apparent that some defects might have been introduced in the disc during reworking which facilitated the fatigue crack initiation. Either they are mechanical in nature such as the stress raisers or residual stresses. Examination did not reveal any mechanical abnormalities and in fact, the dovetail root radius and the surface finish were found as per the reworking specification. However, stress measurements through X-ray technique showed presence of residual tensile stress of about 400 MPa in the dovetail fillet region. The measurements performed on all the uncracked dovetail slots unambiguously confirmed this finding.

It is to be noted that the design specification calls for micro-shot peening operation at the dovetail root region for two reasons. Firstly, this is necessary to eliminate the residual surface tensile stresses introduced during machining operation and secondly, to introduce residual compressive stresses for enhancing the fatigue life of the component. Investigation clearly

established that during reworking, the micro-shot peening operation was omitted. Deficiencies of this type can generally be related to inaccurate, incomplete or ambiguous reworking specifications, but they also can occur as a consequence of human error or negligence.

The above example amply illustrates that during reworking, the component is vulnerable to all those defects, which could have been introduced during fabrication itself. Hence it is of utmost importance that the specification and inspection schedule laid down in the original fabrication procedure are followed during the reworking as well. Any error at this stage jeopardizes the airworthiness of the component as seen in the present case.

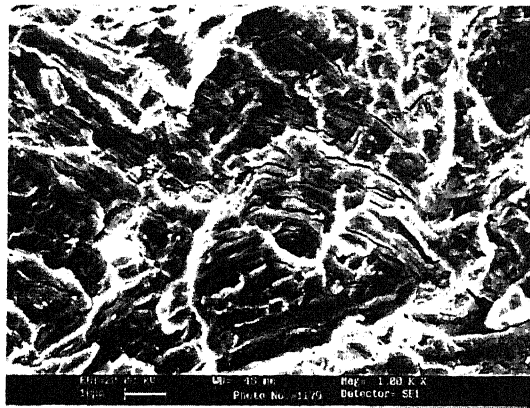
Fig. 2. Fatigue striations

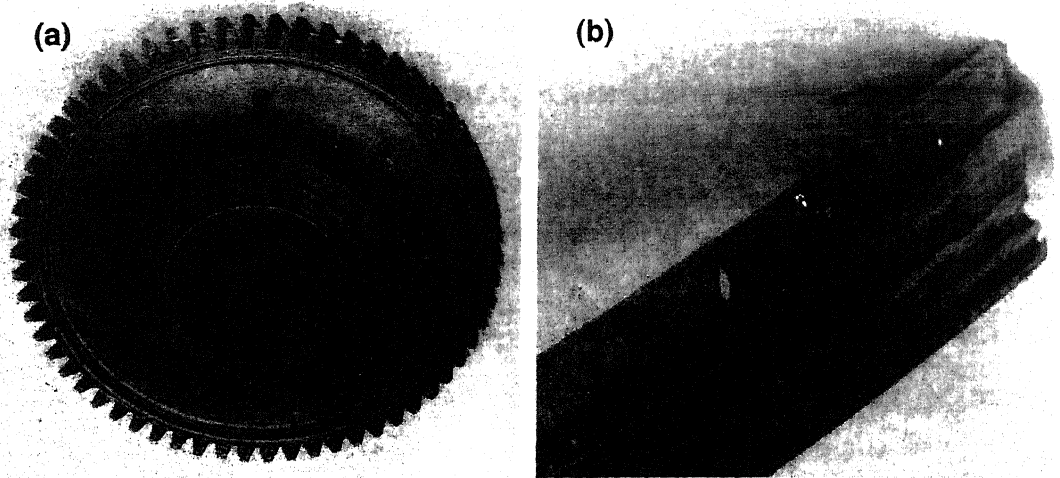
There was an aircraft accident due to failure of the high-pressure turbine rotor (HPTR) disc. The failure was traced to the detachment of the labyrinth. Generally, labyrinth is an integral part of the HPTR disc. Statistics show that a large number of the HPTR discs are withdrawn from service prematurely, i.e., before completion of the total technical life because of the wear out of the labyrinth. This results in huge financial burden on the aircraft operators. To utilize the useful life of the disc effectively, the engine manufacturer suggested an ad-hoc modification of the disc. A reworking scheme was recommended wherein the worn labyrinth was machined out from the disc and a separately fabricated labyrinth ring was interference fitted on to the hub of the disc. The labyrinth ring was located with the help of 60 pins. In this particular case, it was such a reworked disc with a life extension of 1000 hrs. The failure took place after 850 hrs of service in the extended life.

Figure 3 shows the HPTR disc and a part of the detached labyrinth ring. Investigation revealed that the detachment of the labyrinth ring from the disc was the first in the chain of events that led to accident of the aircraft. All the pins used for locating the labyrinth ring were found fractured/sheared.

Fig. 3. Photographs showing (a) HPTR disc and (b) a part of the detached labyrinth ring

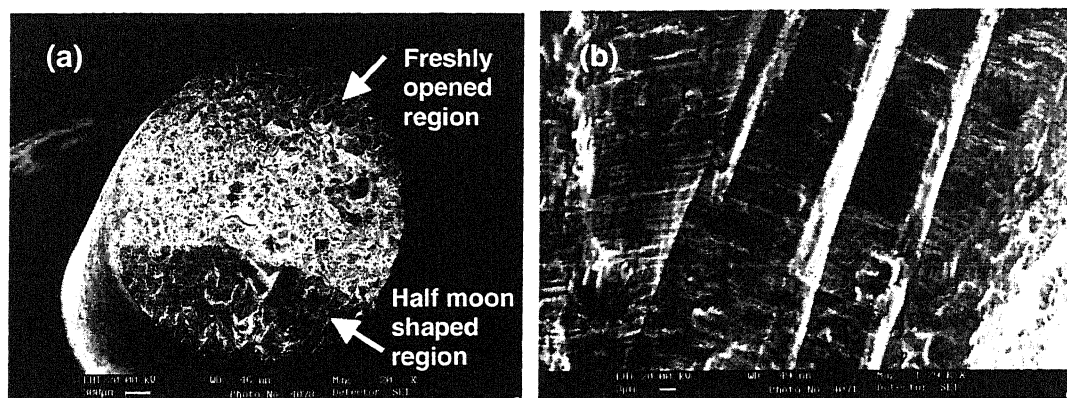
A few pins were taken out from the disc and the fracture surfaces were examined. Fractographic study confirmed that all the pins had fatigue cracks (Fig.4). Analysis showed that the axial movement of the labyrinth ring resulted in deformation of the pins at the ring/disc interface. The stress raiser thus resulted was responsible for the fatigue crack initiation. Hence it was recommended that engines with similar reworked HPTR disc be withdrawn from service and the pins be subjected to examination to look for fatigue cracks, present if any. Following this, six engines with different service lives of the HPTR discs were withdrawn and the pins were subjected to fluorescent dye penetrant inspection. Fatigue crack was identified in majority of the pins that had completed in excess of 220 hrs of service. In all the cases, the fatigue crack was associated with a circumferential depression mark (Fig.5). This study confirmed that there

Fig. 4. (a) Fracture surface of a typical pin and (b) scanning electron fractograph showing fatigue striations

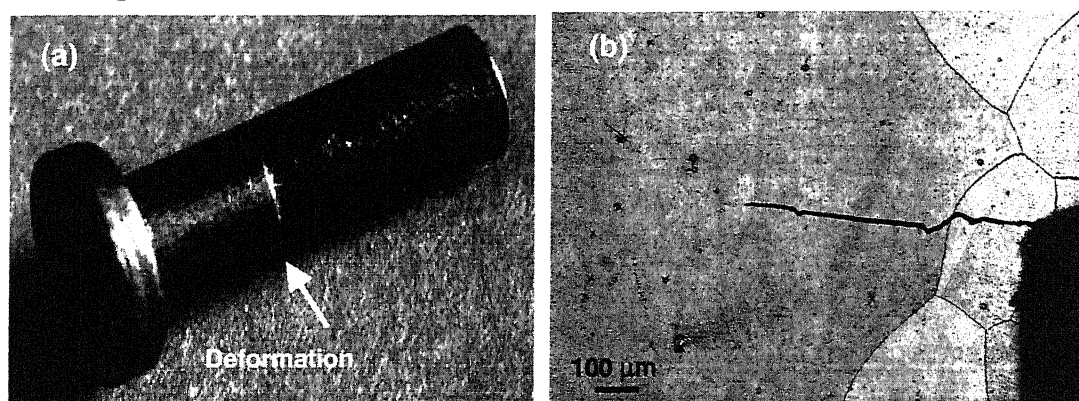
was axial movement of the labyrinth ring in all the reworked discs. It was also proved that such axial movement is unavoidable, and hence the structural integrity and airworthiness of the reworked discs are not acceptable.

Fig. 5. (a) Photograph showing circumferential deformation on the pin and (b) cross section of the pin showing fatigue crack at the deformation mark

Analysis showed that the ad-hoc modification scheme had following deficiencies: (i) inadequate design to prevent axial movement of the labyrinth ring and (ii) no accessibility for inspection of the pins. It was surprising to note that while the HPTR disc had mandatory inspection schedule in every 500 hrs of service, there was no inspection in the reworked region, probably because of the inaccessibility.
